December 14, 2021 Revised February 24, 2022

AAMA 501.6-18 – Recommended Dynamic Test Method for Determining the Seismic Drift Causing Fallout from a Wall System

<b>Report of:</b>	
PREPARED FOR:	Porcelanosa USA 600 Route 17 North Ramsey, NJ 07446
PROJECT NUMBER: REPORT NUMBER: REPORT DATE: TEST DATE:	476631-2 CW21- 295 December 14, 2021 DECEMBER 9, 2021 AAMA Accredited Lab since 1983 OSHPD Approved Lab #OPL-0015-14 and #OPL-0020-15 DSA LEA Lab Approval # 25 and # 56

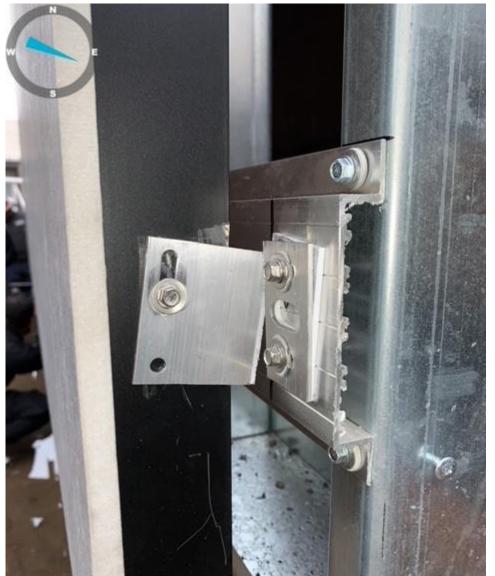
AAMA 51.6 test Completion of 4 inch displacement Bro screws pulling from the hat channel and the stud Thursday, December 9, 2021 at 1:56:43 PM Pacific Sta

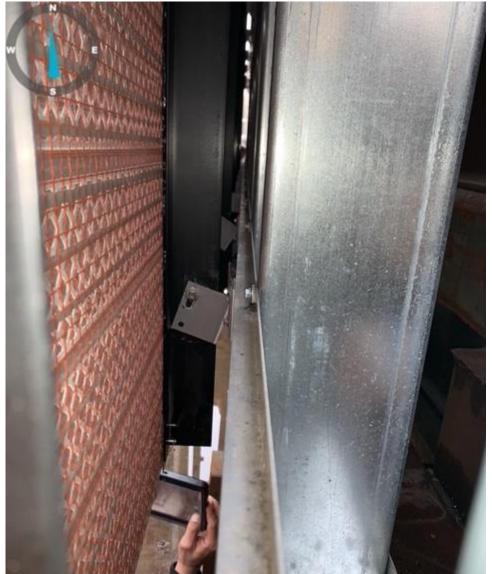
AAMA 51.6 test Completion of 4 inch displacement Bro screws pulling from the hat channel and the stud Thursday, December 9, 2021 at 1:5700 PM Pacific Sta

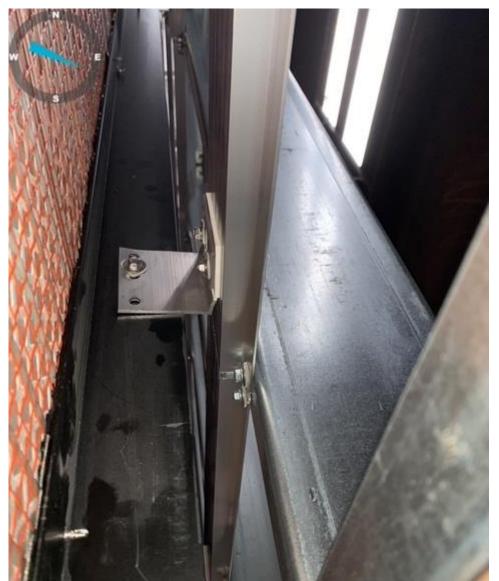
AAMA 51.6 test Completion of 4 inch displacement Bro screws pulling from the hat channel and the stud Thursday, December 9, 2021 at 1:57:20 PM Pacific Sta

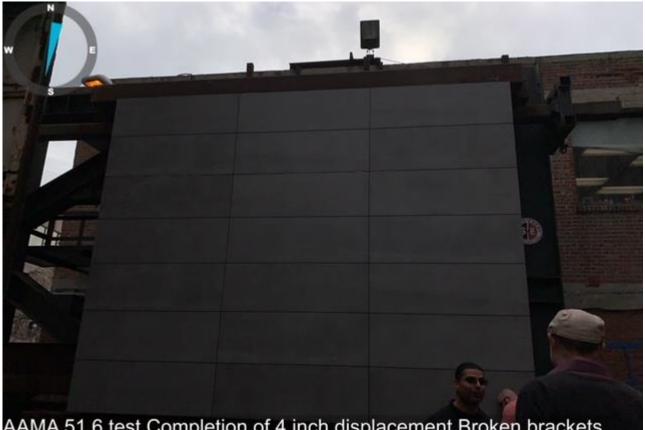
2.2.1. Damage was observed at the bottom angle clips after 4" displacement.

AAMA 51.6 test Completion of 4 inch displacement Broken brackets screws pulling from the hat channel and the stud Thursday, December 9, 2021 at 1:58:11 PM Pacific Standard Time

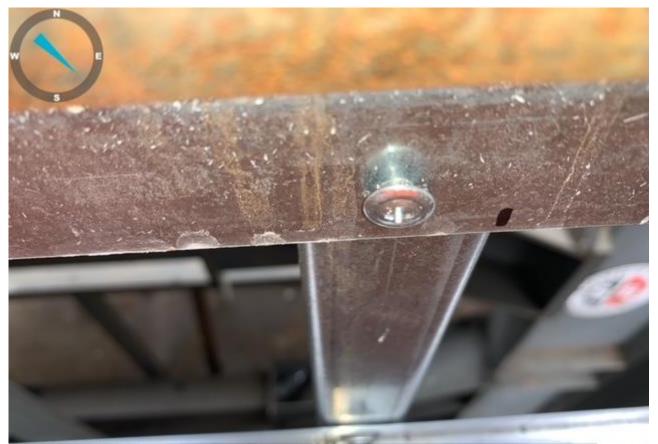
AAMA 501.6 Completion of 6 inch Displacement Thursday, December 9, 2021 at 2:20:29 PM Pacific Standard Time
